MRL-R-658

INTERACTIONS BETWEEN F-111 FUSELAGE FUEL TANK SEALANTS

PART 2. VARIATION IN PERFORMANCE PROPERTIES OF POLYSULFIDES

AFTER CONTACT WITH POLYESTER DEGRADATION PRODUCTS

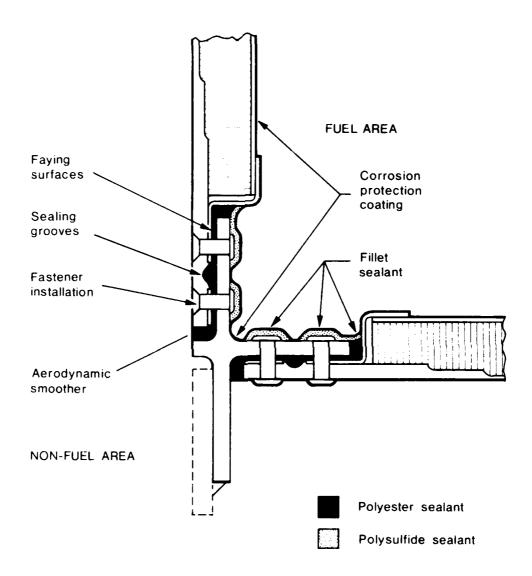
Fuel storage in the F-111 aircraft is maximised through use of integral tanks formed by sealing available cavities in the fuselage, wings and vertical stabiliser. For the fuselage fuel tanks a multiple barrier design was introduced (Figure 1) which involved two types of sealant. Fasteners and seams within the tanks were coated with fillets of polysulfide, the conventional sealant for applications which involve direct contact with fuel. Faying surfaces and voids, however, which were expected to experience greater aerodynamic heating, were sealed with a thermally resistant polyester material of undisclosed formulation which was designated as EC 5106. This sealing concept was intended to provide the capability to counter fuel leaks by introduction of sealant from the exterior of the aircraft through a series of injection holes. These allow sealant to enter grooves milled into faying surfaces and pass into the cavity responsible for the leak.

Figure 1. Multiple barrier sealing system in the F-111 fuselage fuel tank.

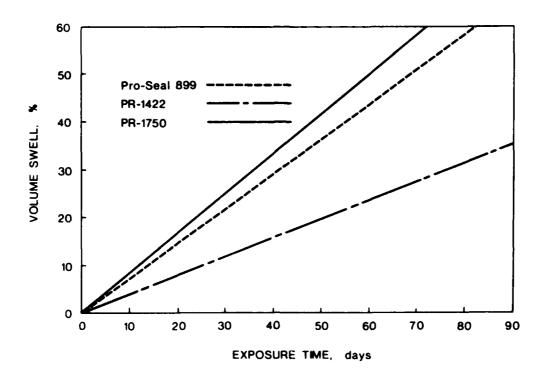
Figure 3. Changes in volume swell of polysulfide sealants after conditioning at 90° and 100% relative humidity.

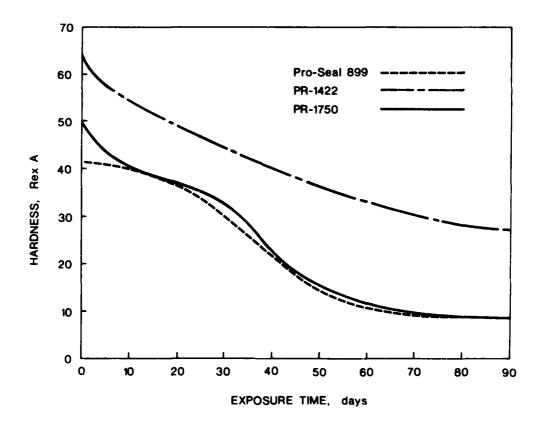
Figure 4. Effect of conditioning at 90° and 100% relative humidity on the hardness of polysulfide sealants.

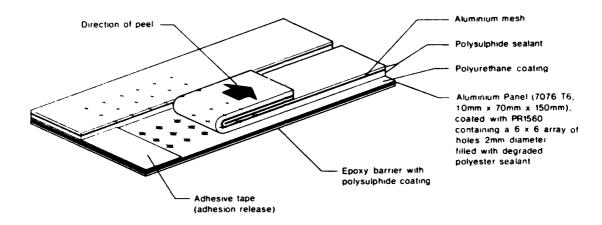
A array of 36 holes of 2 mm diameter was drilled over half the panel surface (see Figure 5). The rear face was then coated with polyethylene to provide a temperary filling in the apertures. This was achieved by placing the panel on a polyethylene sheet (1 mm thick), each side of the panel was then covered with teflor sheet and finally the sandwich was press moulded at 150° and 6.9 MPa for 2 min.

Figure 5. Modified peel panel for assessment of the effect of degraded polyester on the adhesion of polysulfide sealants.

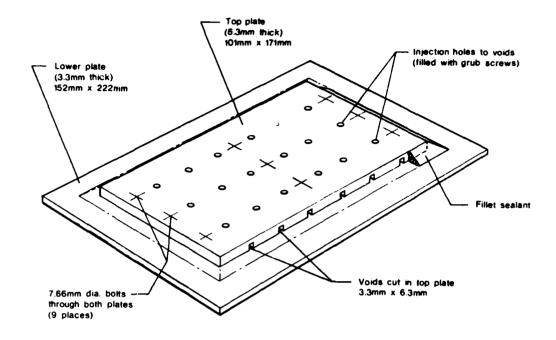
A structure which simulates the sealed faying surfaces, injection holes and structural voids of a fuel tank was constructed of polyurethanecoated aluminium alloy panels (Figure 6) [2]. Degraded EC 5106 polyester sealant was introduced into the voids between the upper and lower plates which were then bolted together and grub screws inserted in the injection holes. Various combinations of epoxy barrier coats and polysulfide sealants in both normal or broad fillets (see Figures 7-10) were then applied around the sides of the panels. The cross-section of the normal fillet formed a right-angled triangle (Figure 7) with a base of 5 mm. The broad fillets had a base of 10-12 mm and the profile of the upper surface was slightly convex. Sufficient panels were used to provide quadruplicates of each combination of materials. After standard cure the specimens were placed on their sides in desiccators containing saturated K₂SO₄ solution (which provided a relative humidity of 95%) and these were maintained in an oven at 95°. The panels were examined regularly for changes in fillet configuration and a photographic record was maintained. With time, polyester degradation products exuded from the grub screws and flowed down the plates eventually contacting the polysulfide fillets. To prevent this effect, the grub screws were sealed externally with epoxy adhesive. This was carried out on all panels which were still in satisfactory condition after 35 days.

Figure 6. Simulated fuel tank structure used for determination of the relative effectiveness of barrier seals.
